Negative Pressure Operating Theater Local Experience

United Christian Hospital

8057MM - Enhancement of Infection Control Facilities
In the Public Hospital System (Batch B)
For United Christian Hospital (UCH) (SARS Mode)

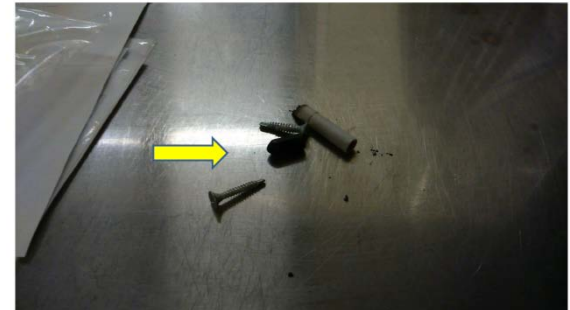
Screws & cigarette left on the false ceiling

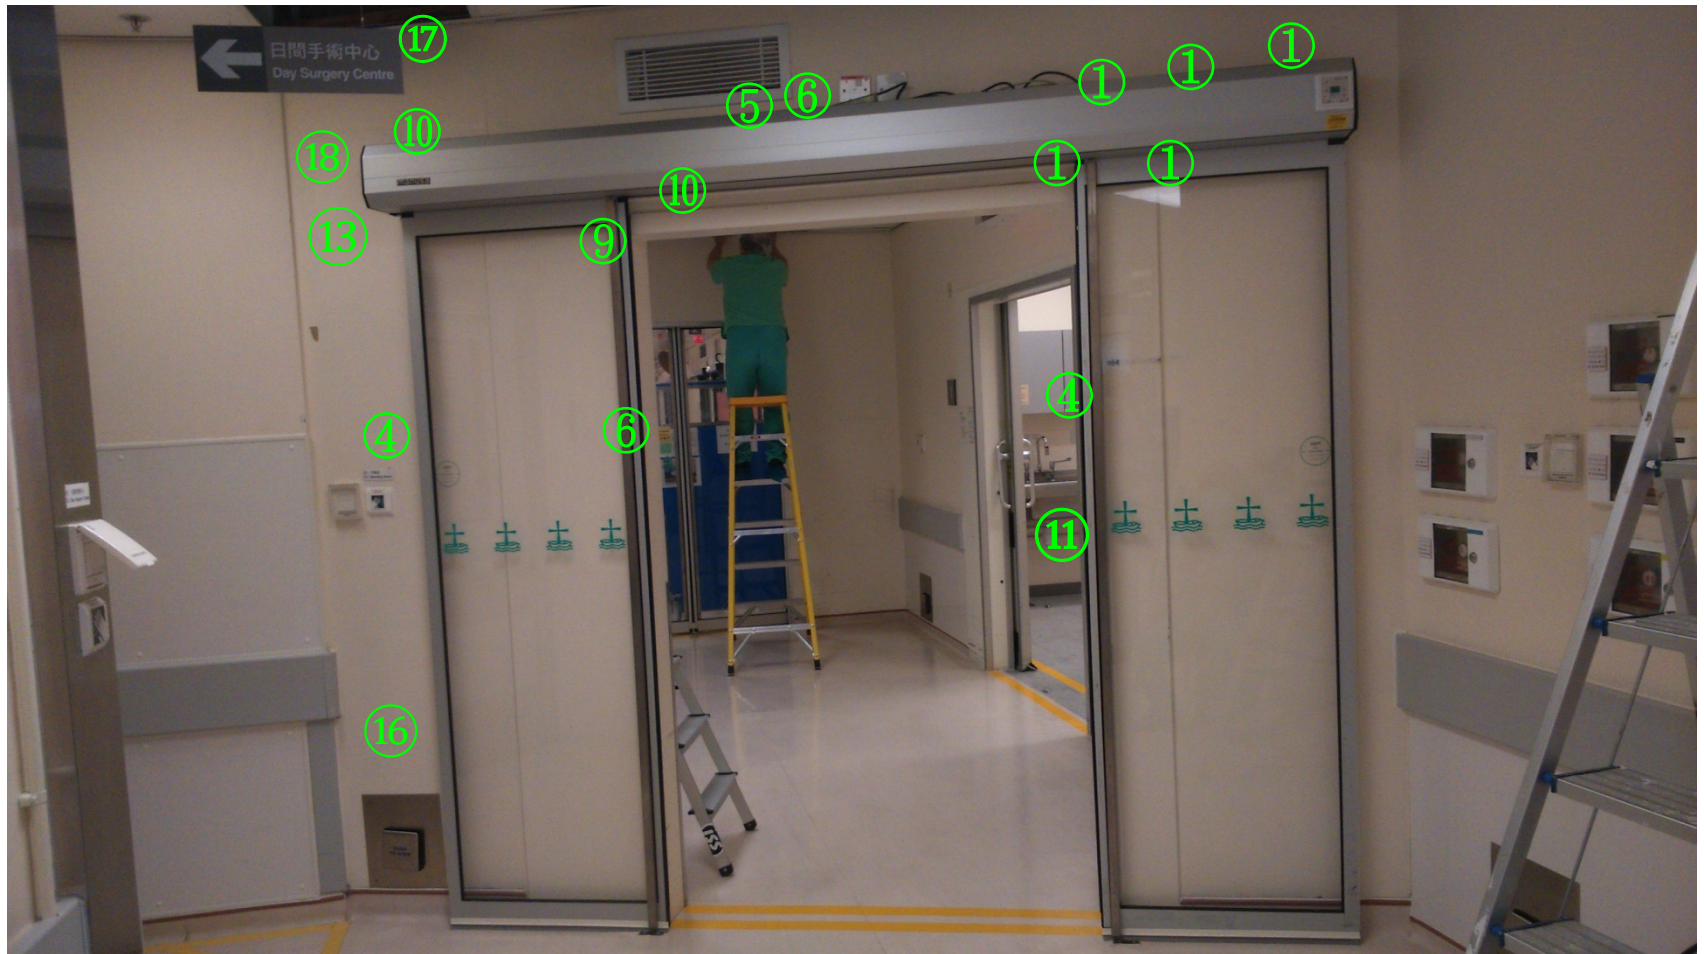
Environmental swabs

Around the auto door between OT1 & Day Surgery

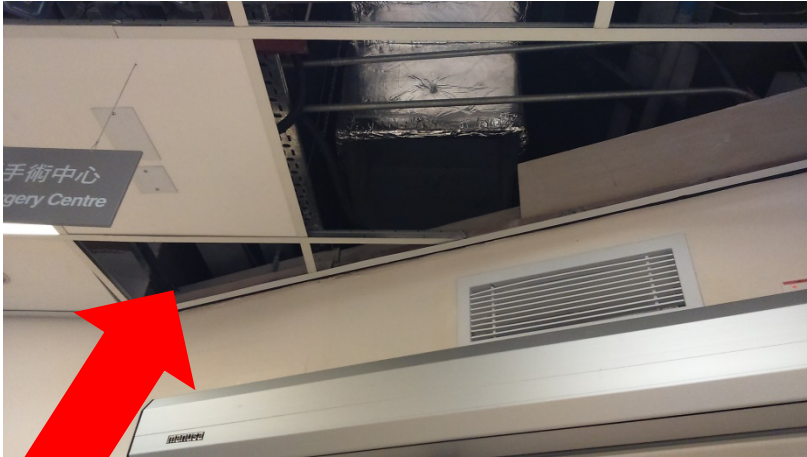
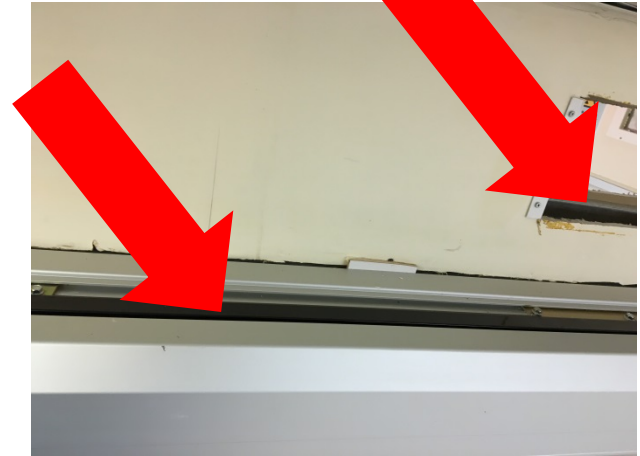
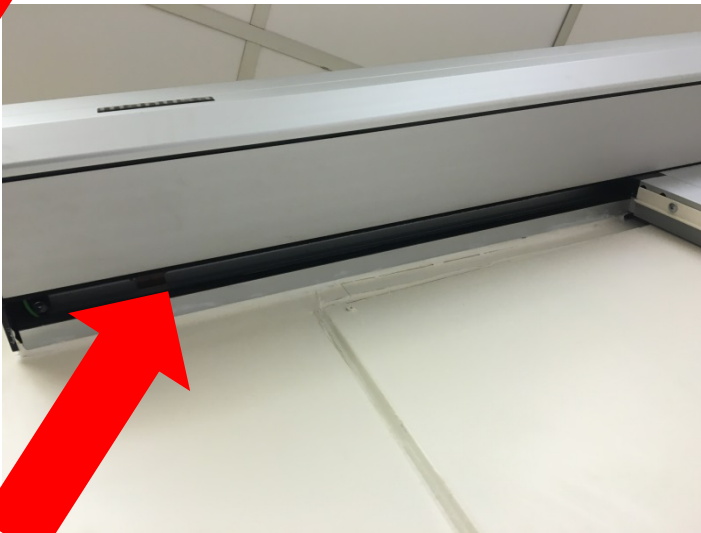
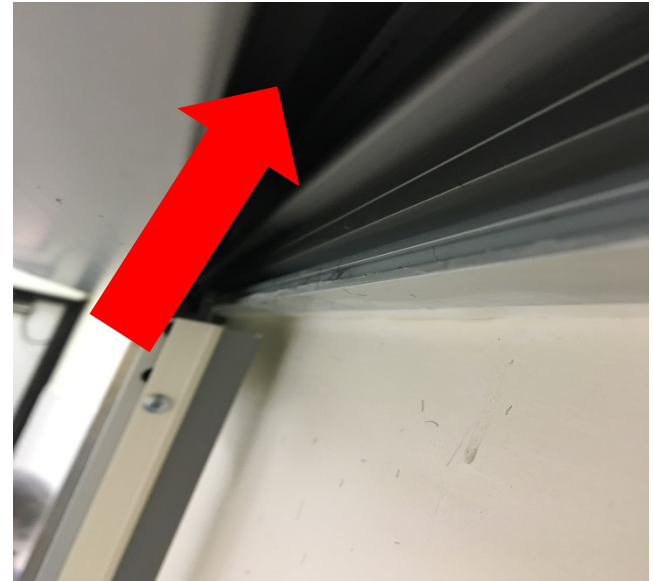
Massive leakage from ceiling water pipe a few months ago

Fungal colonies cultured from the wooden/plaster structures/gaps around the auto door

- Remove all seals of the auto door
- Remove the wooden/plaster structure in the false ceiling and louver where possible
- For those parts that could not be removed, coated with anti-mold painting and erect barriers to seal them from surrounding areas
- Comprehensive cleaning and disinfection
 - The ceiling and all surfaces in linkage area of day surgery and clean corridor outside OT1
 - All surfaces in scrub room, anesthetic room, OT1 and dirty corridor
 - All cleanable parts around auto door and louver
- Air-out 24 hours, repeat air and environmental sampling

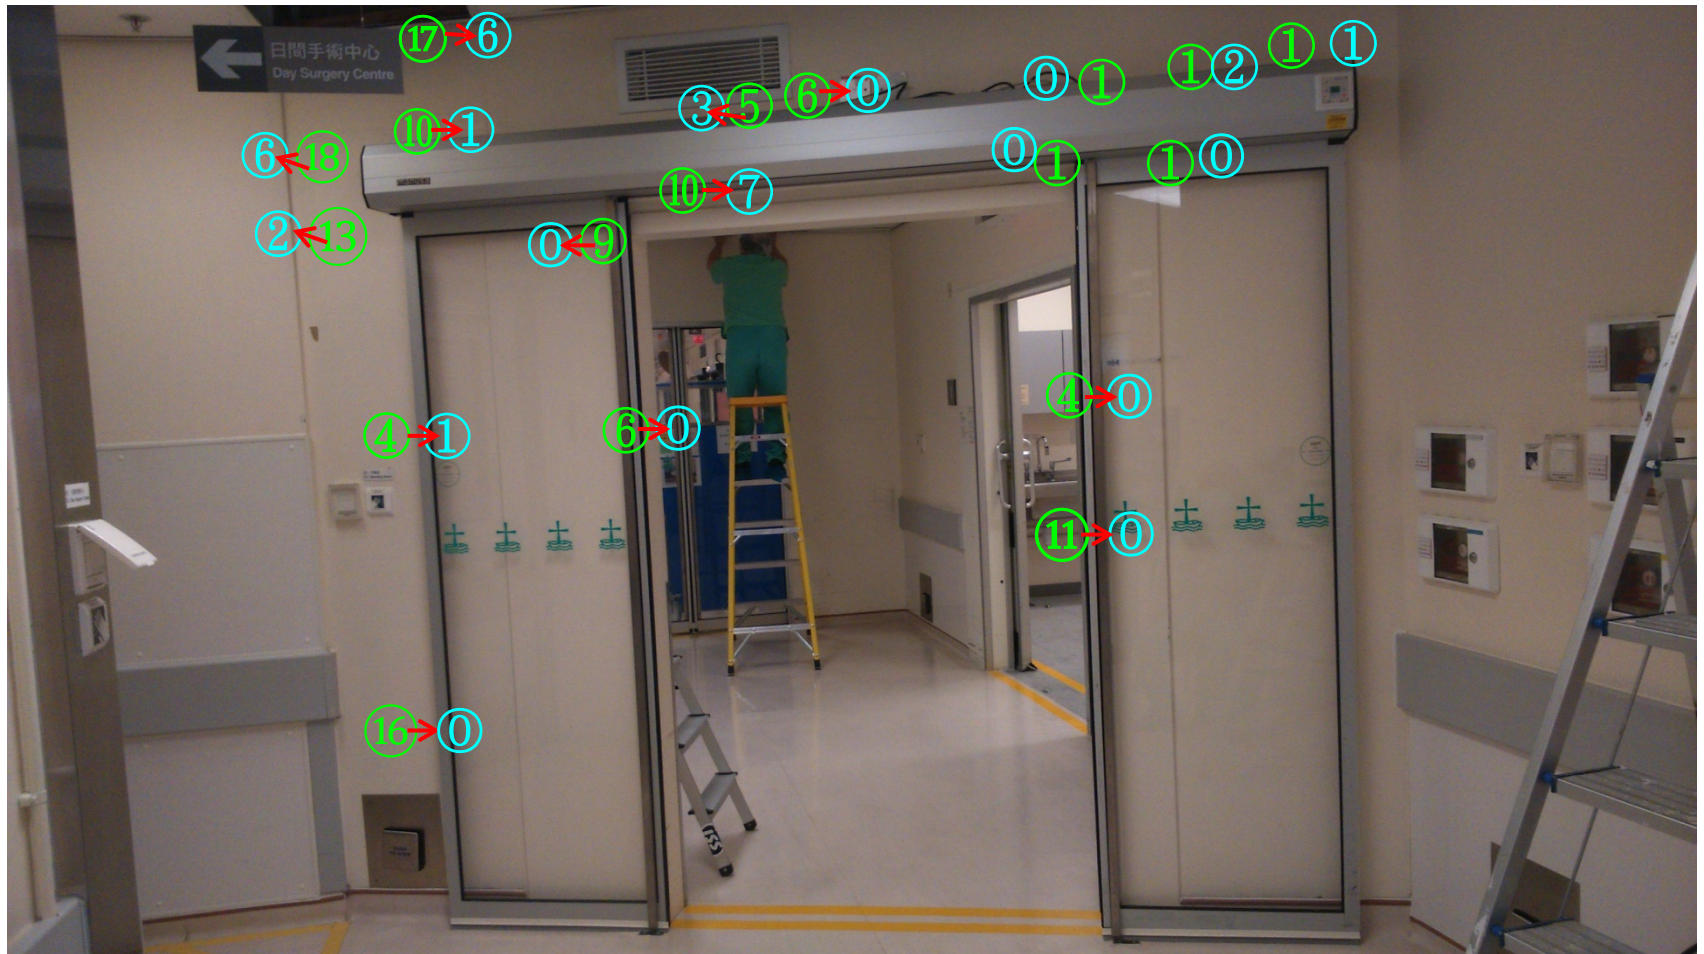
Repeat environmental sampling

⑥ swabs on 1 Mar

⑥ swabs on 3 Mar

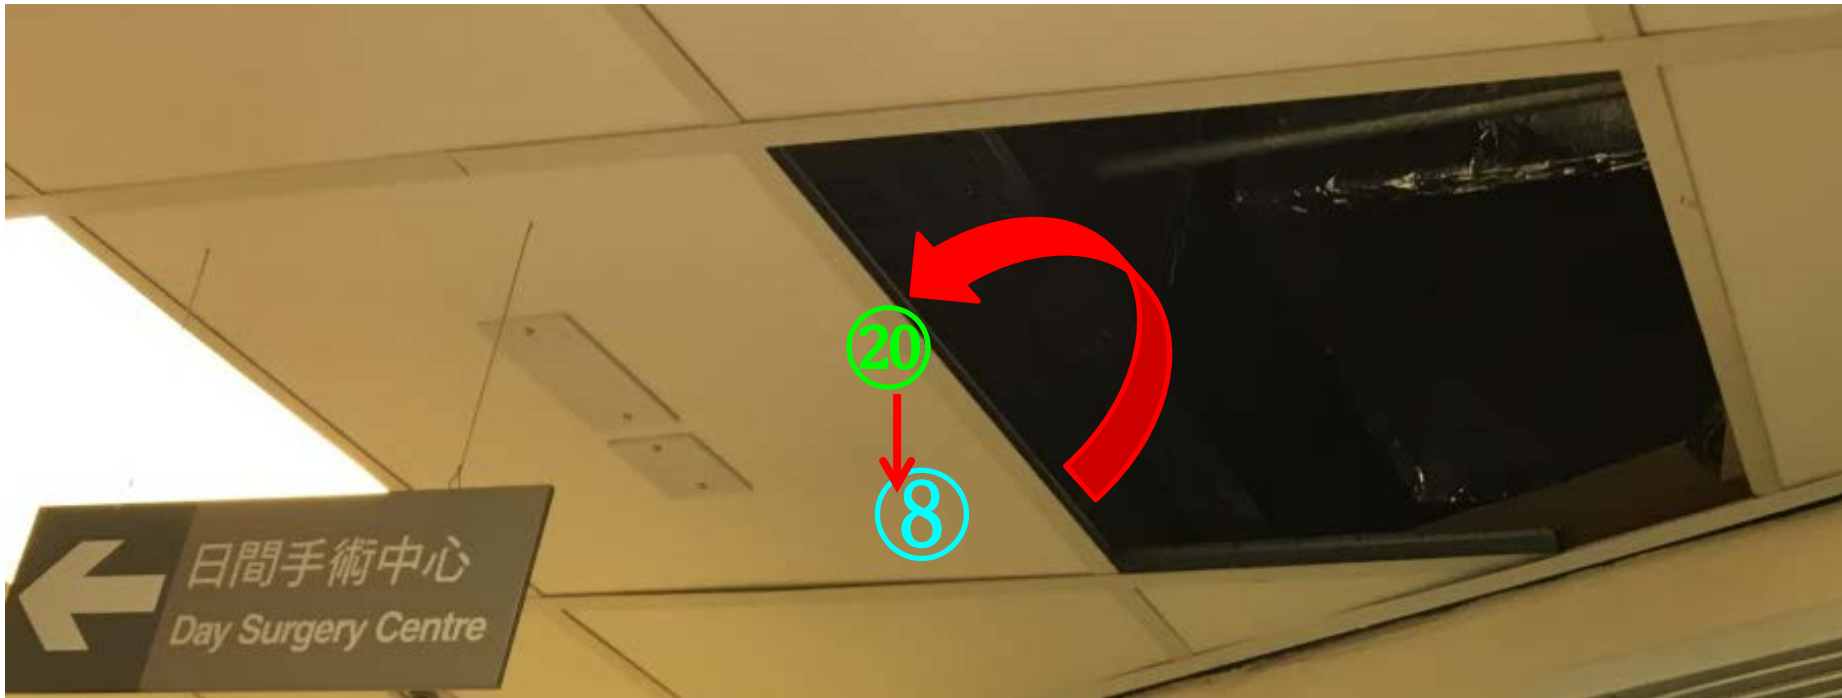
Environmental sampling on 3 Mar

Ceiling of auto door between OT1 & the Day Surgery

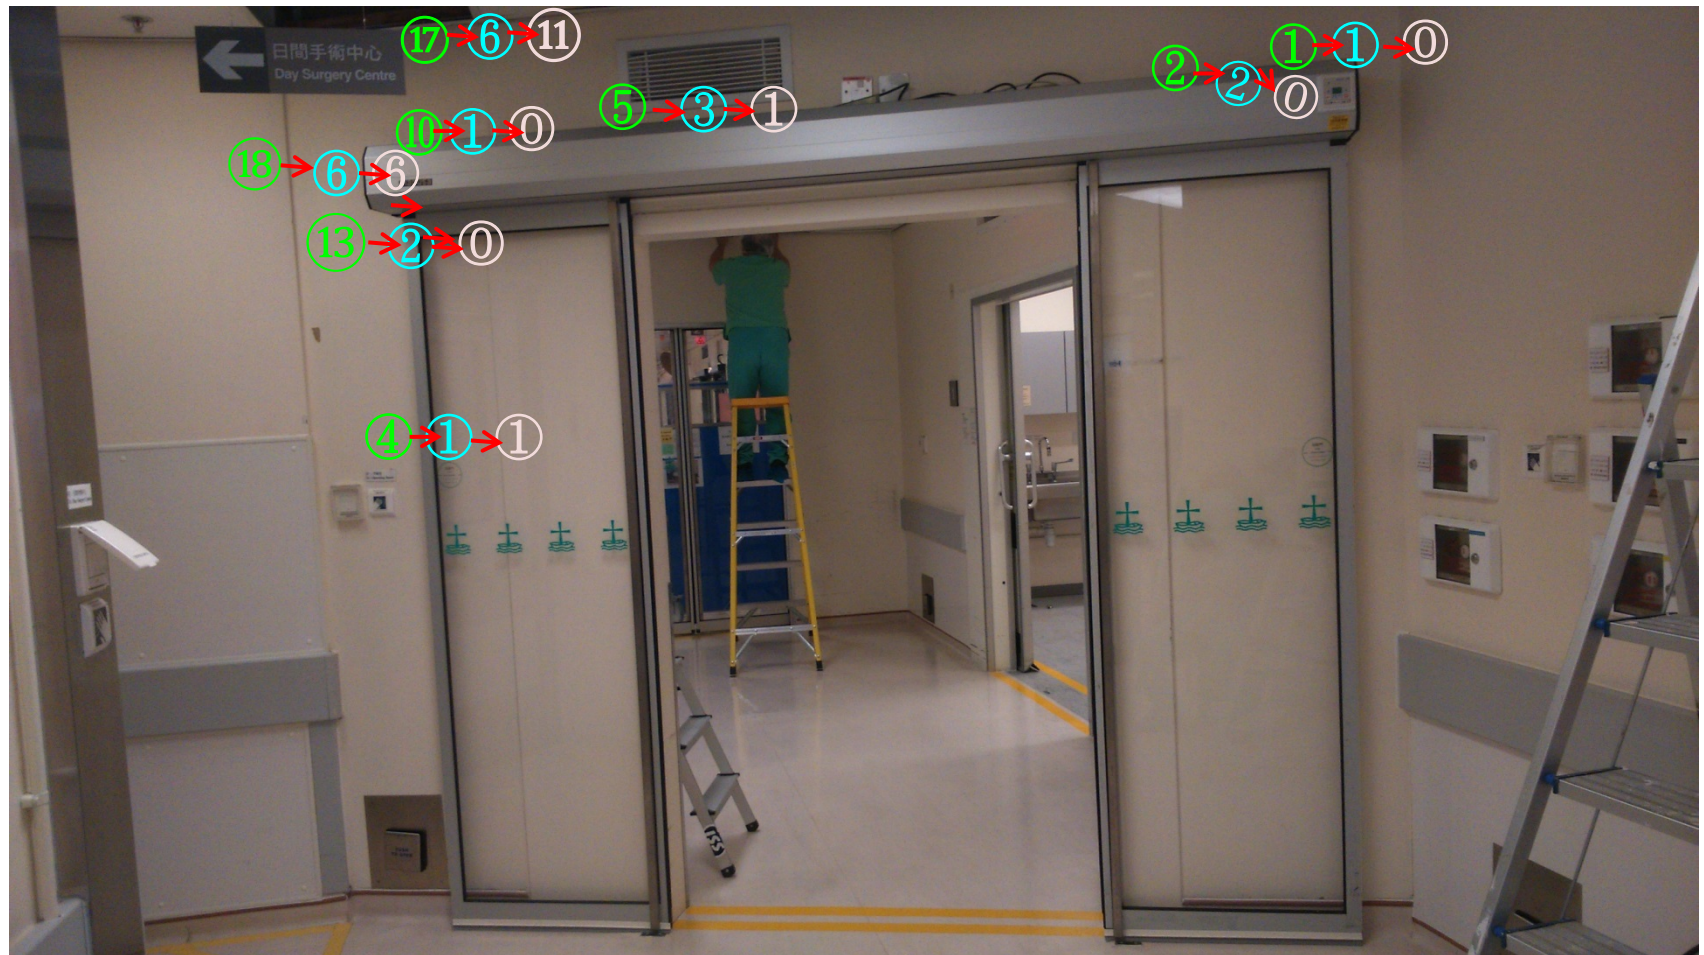
After removal of wooden / plaster boards

⑥ swabs on 1 Mar ⑥ swabs on 15 Mar
⑥ swabs on 3 Mar

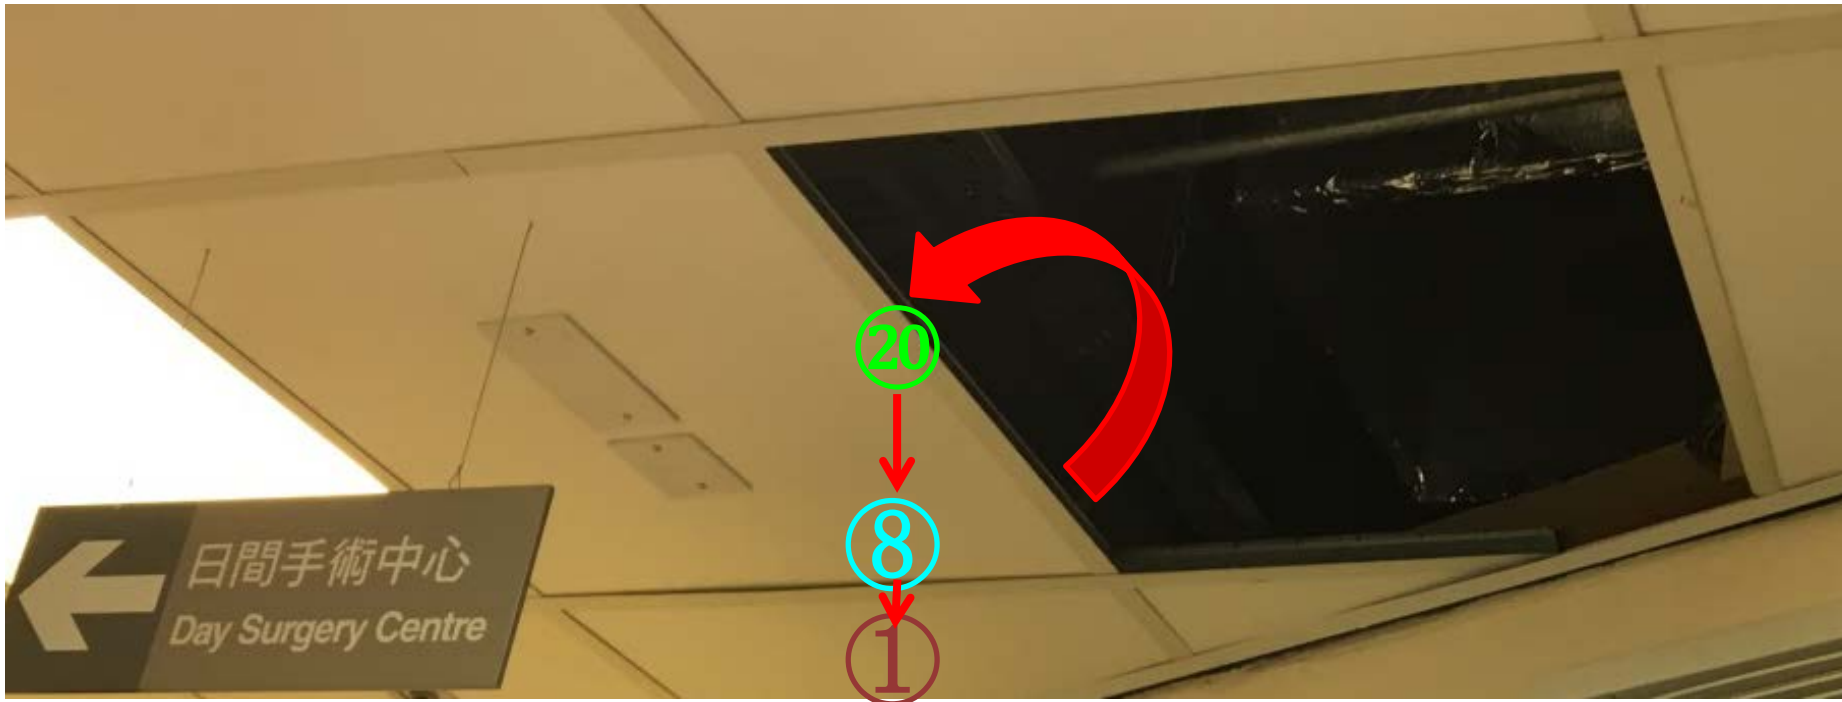
After removal of wooden / plaster boards
