Fungal infection and susceptible hosts

Dr Ling Moi Lin

Director Infection Prevention & Epidemiology Singapore General Hospital

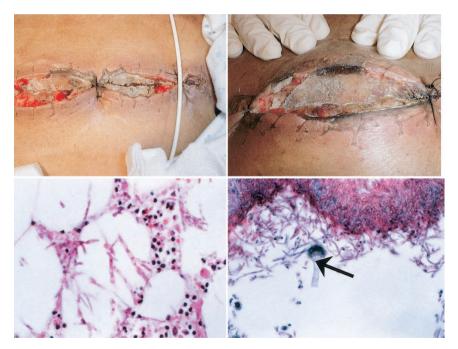
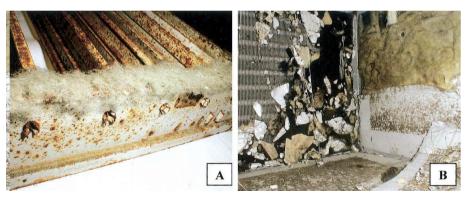
A, Operating room diffuser showing fiberglass fragments from insulation blown downstream from a variable airflow volume (VAV) unit. Severe rusting is indicative of intermittent or chronic condensation.

B, Interior view of a VAV unit showing deterioration of foil-lined fiberglass insulating material.

- Hot weather, frequent rains
 - Promoted condensation in air ducts in the operating theater
- All ORs received 15 ACH through individual variable airflow volume (VAV) units located in the ducts just downstream from final filters
 - VAV units allow adjustment in room air exchange rates via airflow dampeners and air temperature control via water-jacketed radiative elements
 - VAV units installed to improve energy efficiency through air- flow and temperature control

- VAV units <u>should not</u> be used downstream of humidification systems or be allowed to interfere with air exchanges in patient care area
- In general, no material should be installed in duct- work beyond final filters
- Facilities using VAV units in air-handlers for clinical areas where patients are at risk for nosocomial infection may wish to verify that interior insulating liners are not present or are in good condition.

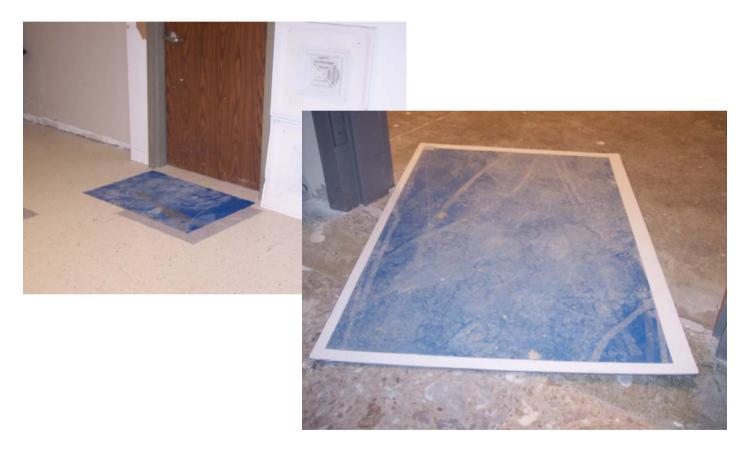
Dust mats need to be maintained

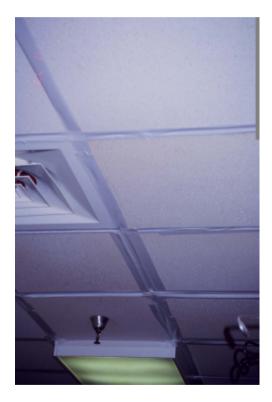
Vibration may move ceiling boards!

- Watch out for dislodged ceiling boards.
- Call IPC
