Outbreaks During Design & Construction of Health Care Facilities

Hospital Authority/Infection Control Branch, Centre for Health Protection

Linda L. Dickey, RN, MPH, CIC
January 15, 2014

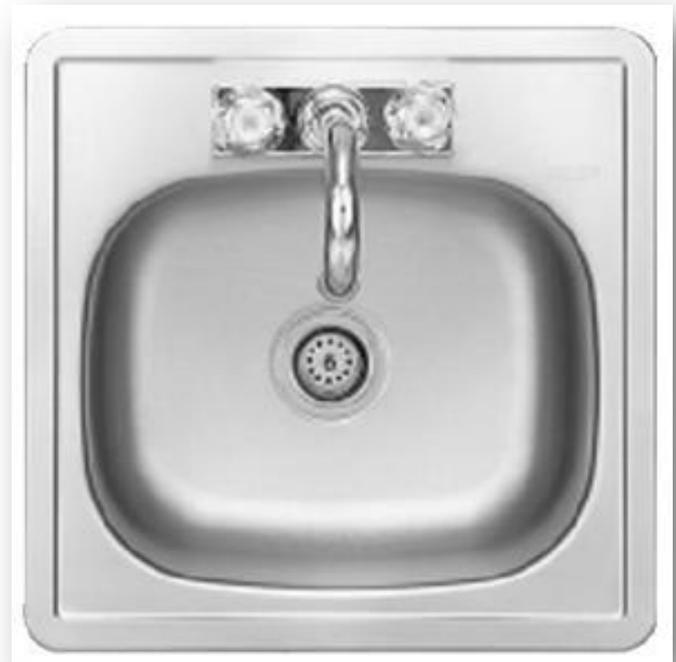
Sink design with spout directly over drain and shallow basin facilitates splashing

- **36 cases of infection, including 17 deaths**
- **Outbreak strain of *P aeruginosa* found in sink drains; sink placement and design contributed to transmission**
 - Splashes from sink drain found 1 m from sink
 - Contaminated medication and sterile dressing area
- **Lessons learned:**
 - Sink design matters—sufficient depth and drain to spout offset
 - Need sufficient space between sink and clinical adjacencies

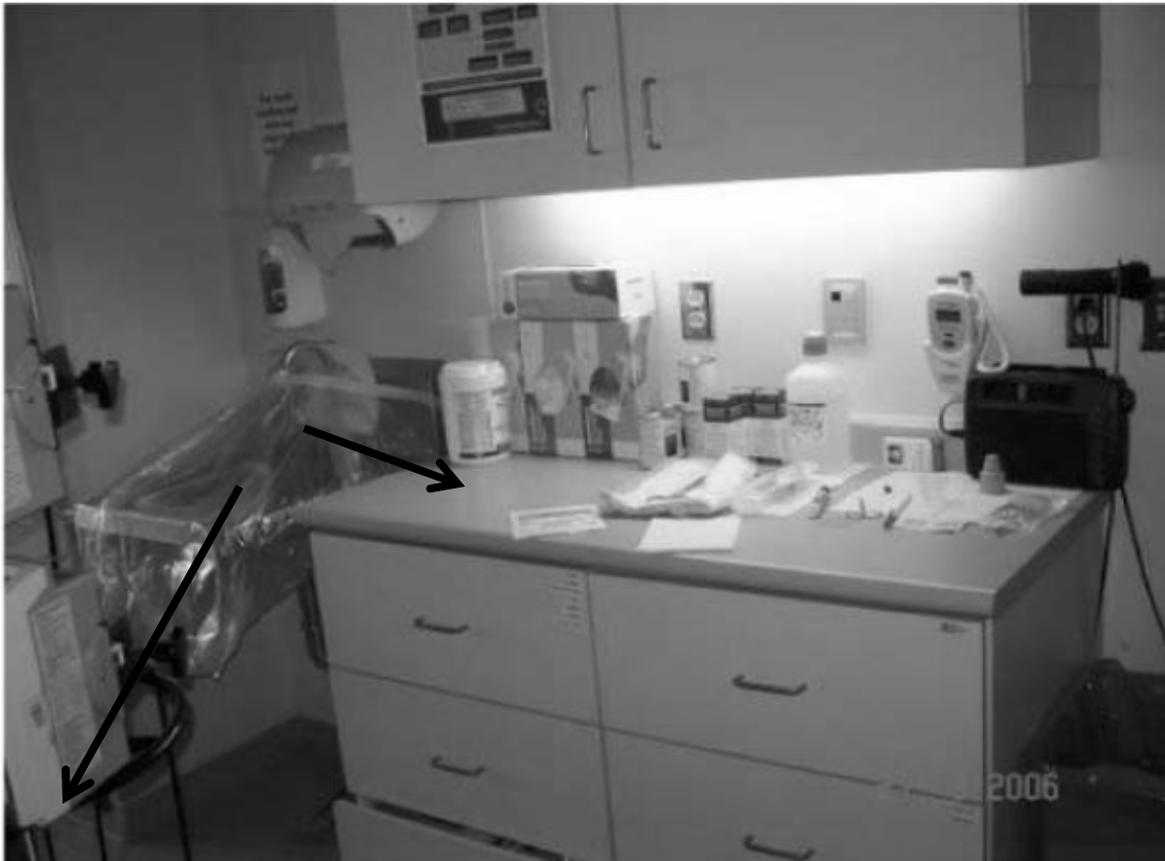
Proximity of sink to counter space and patient allowed for contamination

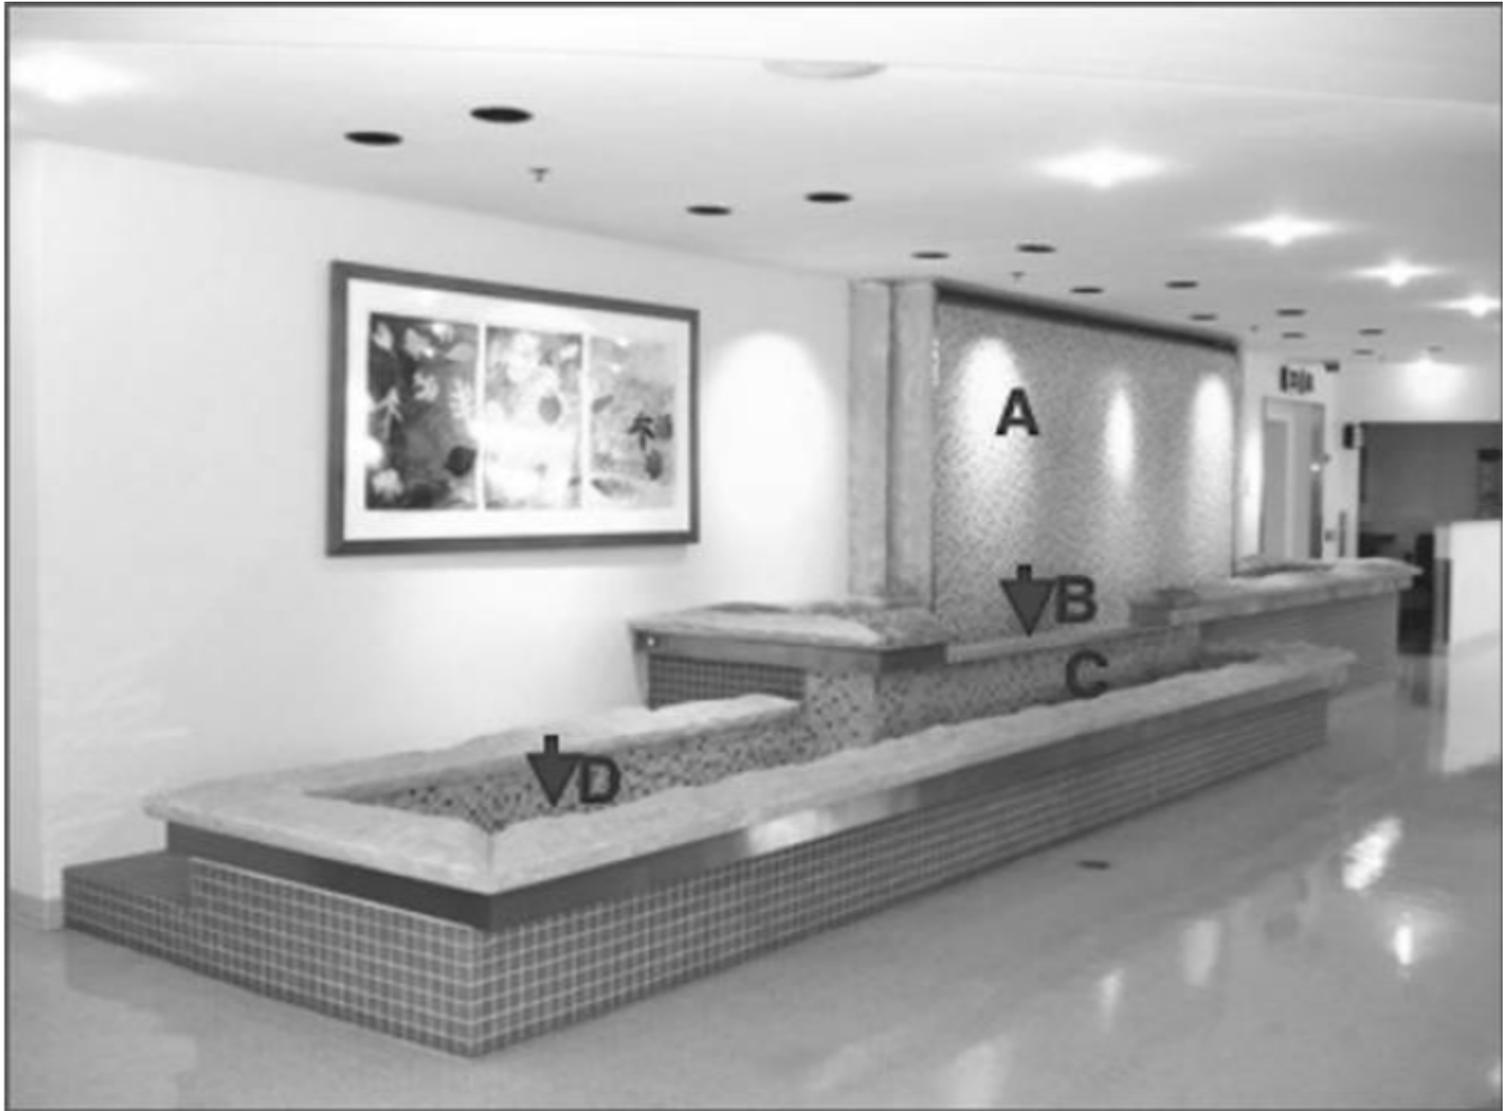
- **Both patients had contact with a decorative water fountain in the Radiation Oncology Suite**
- **L. pneumophila serogroup 1 recovered from both patients & fountain water**
Both patients reported observing the fountain at close range
- **Lessons learned:**
Water in pipes to fountain allowed to sit stagnant 4 months before restarting
Design combined filtered water with municipal water

- **The Joint Commission: Requires ICRA and ICRMRs**
- **CDC Environmental Guideline**
- **2014 FGI Guidelines**
 - Multidisciplinary development
 - Building code for 40+ U.S. states
 - Referenced by U.S. regulators (e.g. CMS, TJC)
 - Provides minimum standards, best practice
 - **Prohibits indoor, open water features in inpatient & outpatient health care facilities**
